# Southern WV Safety Alert

Two mantrip accidents recently occurred at two separate mines due to inadequate preoperational checks and maintenance.

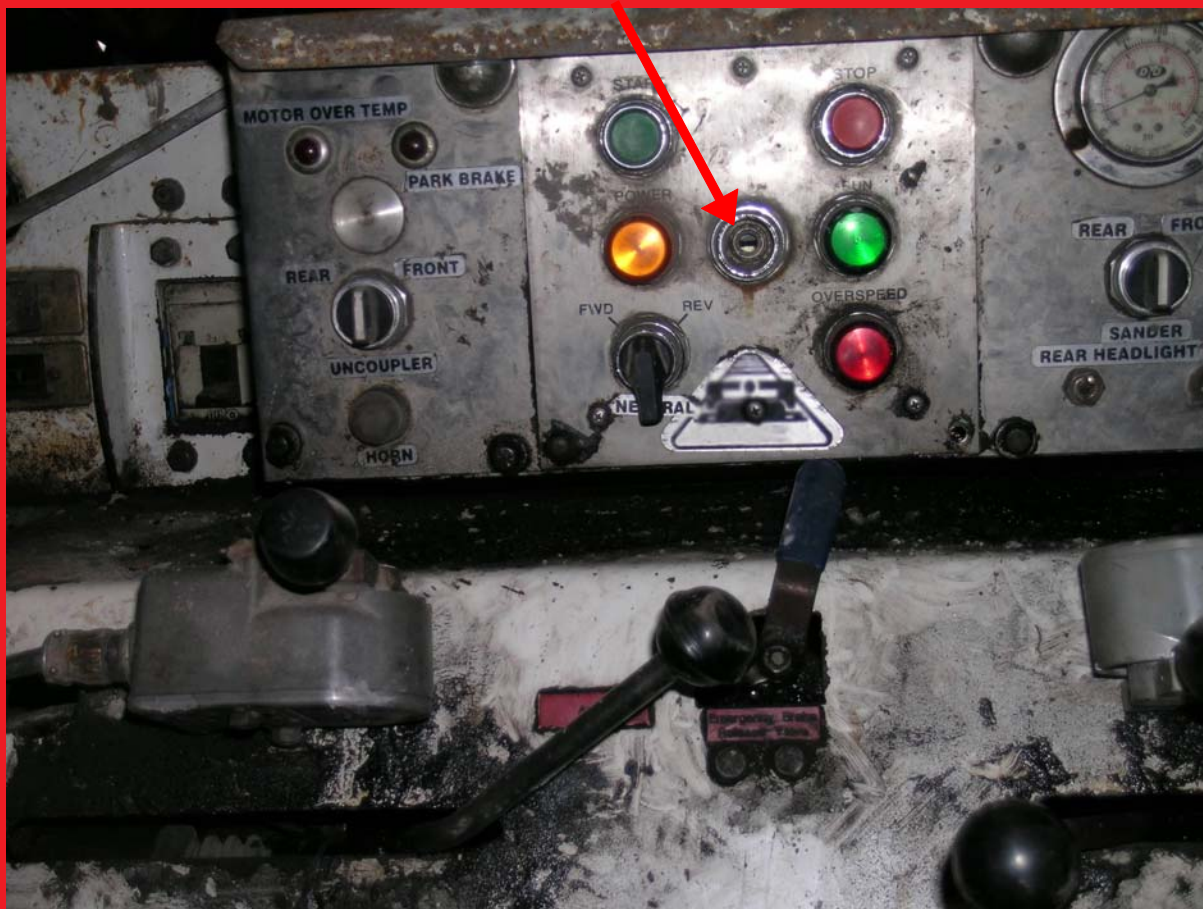
**Accident # 1:** After the service brake failed, a mantrip traveled down a mine grade and collided with another mantrip, causing injuries to three miners. The mantrip's brakes were contaminated with metal and a foreign fluid and the emergency brake actuator had been broken off. There was an accumulation of oil and grease on the brake disks, further reducing brake application.

Note where the emergency stop actuator should have been.

- ✓ Track equipment should be frequently examined and properly maintained to assure safe operating conditions.
- ✓ Never operate unsafe or poorly maintained equipment.
- ✓ All hazards that affect the safe operation of equipment must be reported and repaired prior to operating the equipment.
- ✓ All miners assigned to operate equipment should be trained in its operational capabilities.

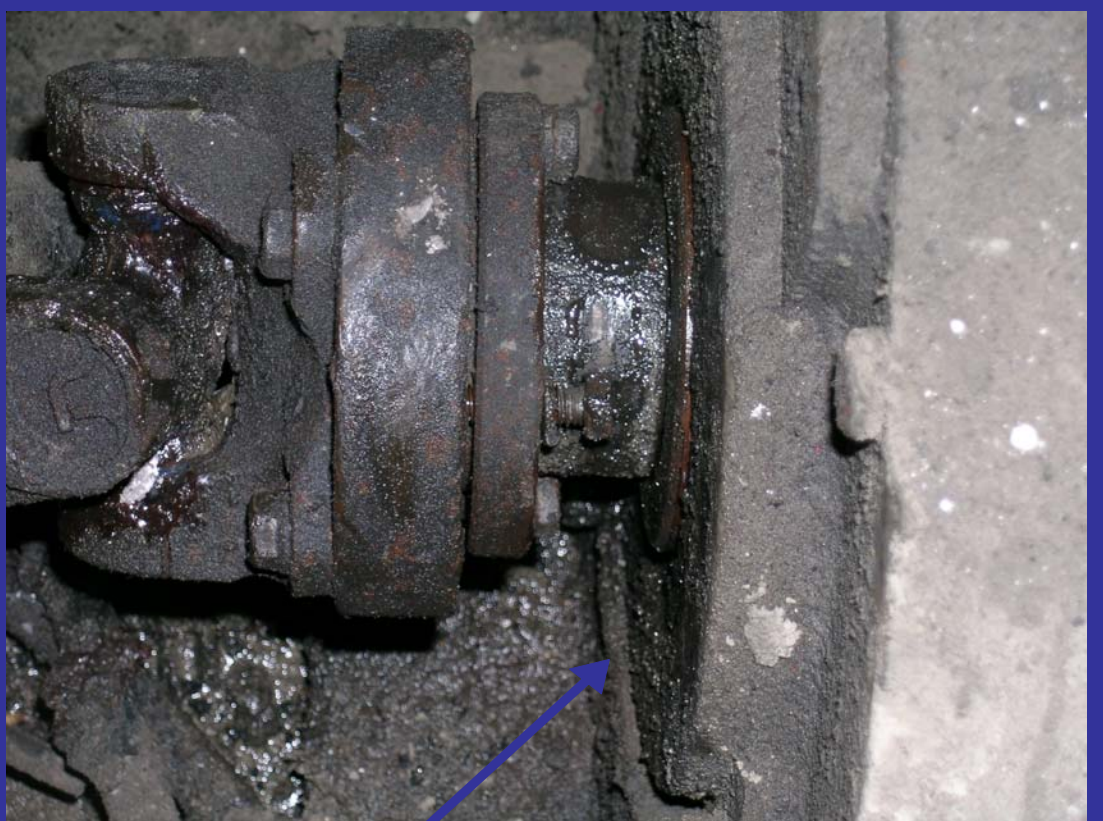
Note accumulation of oil/grease on brake rotor.
